Arboriculture Assessment & Management Statement

January 2021

Site: Lot 32 in DP 653913
79 Newton Road
STRATHFIELD, NSW

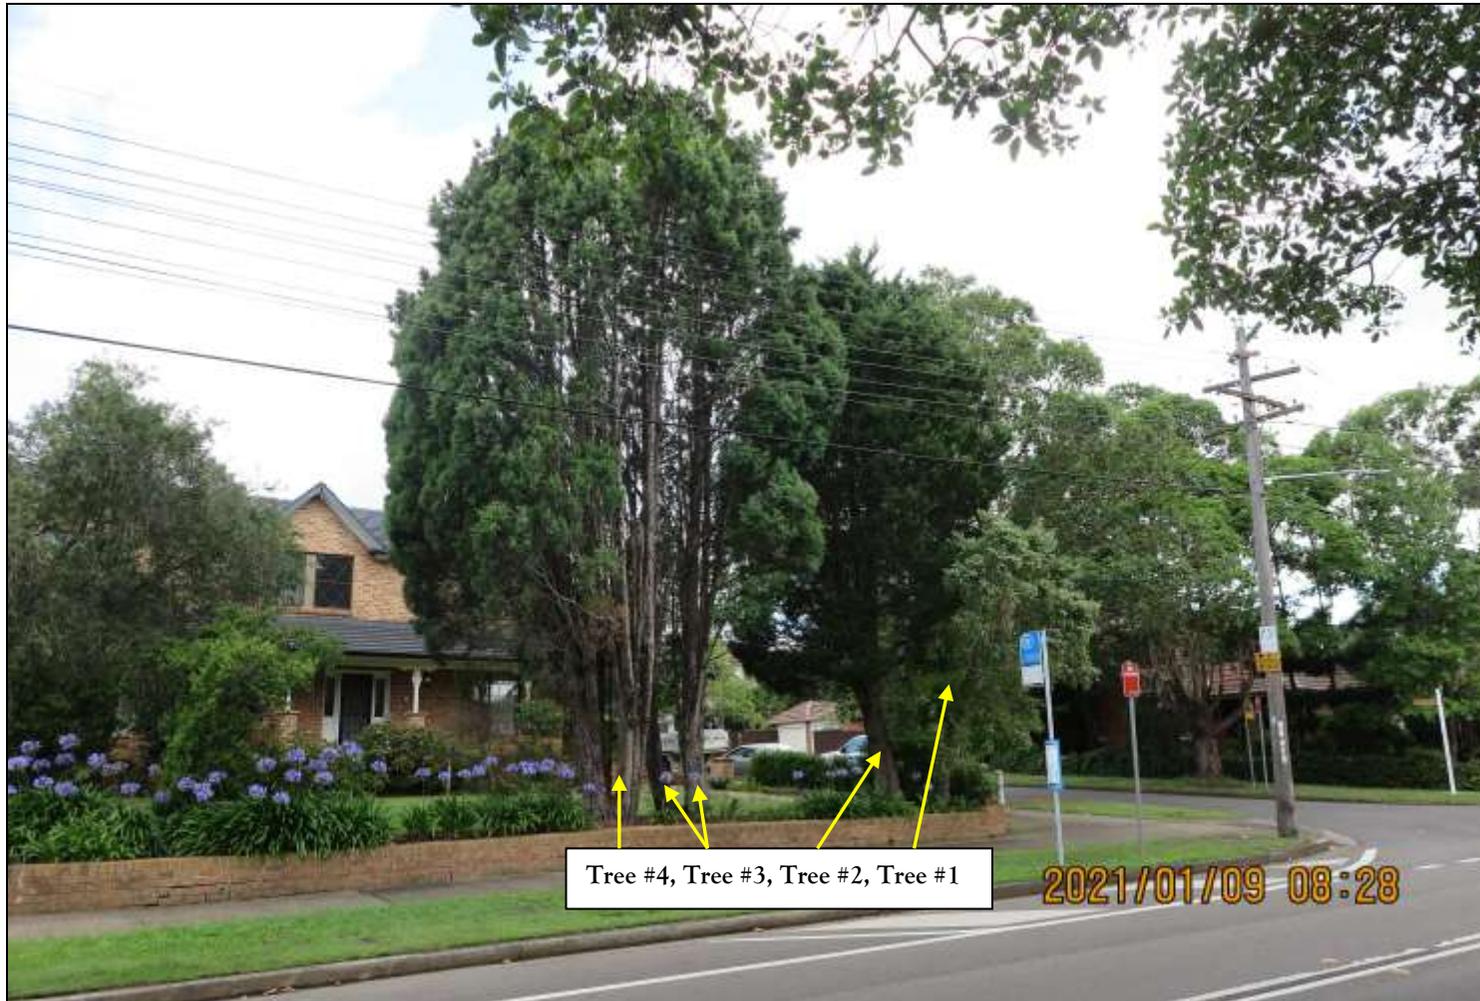
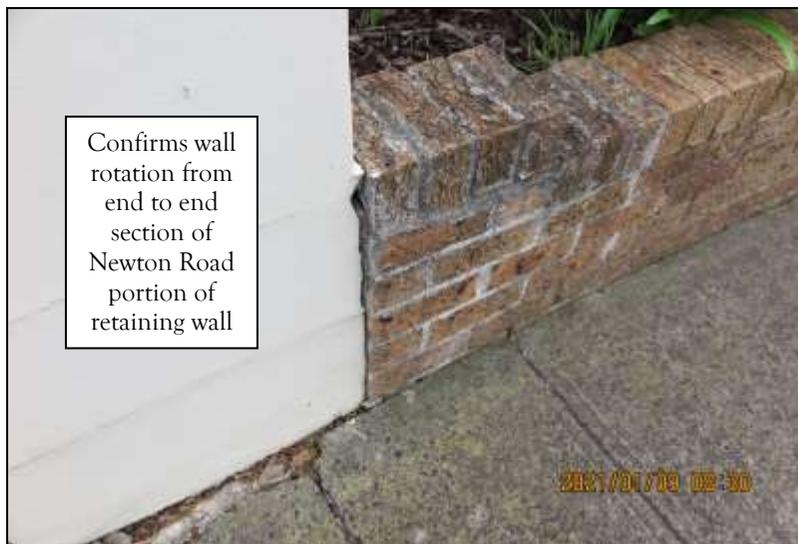
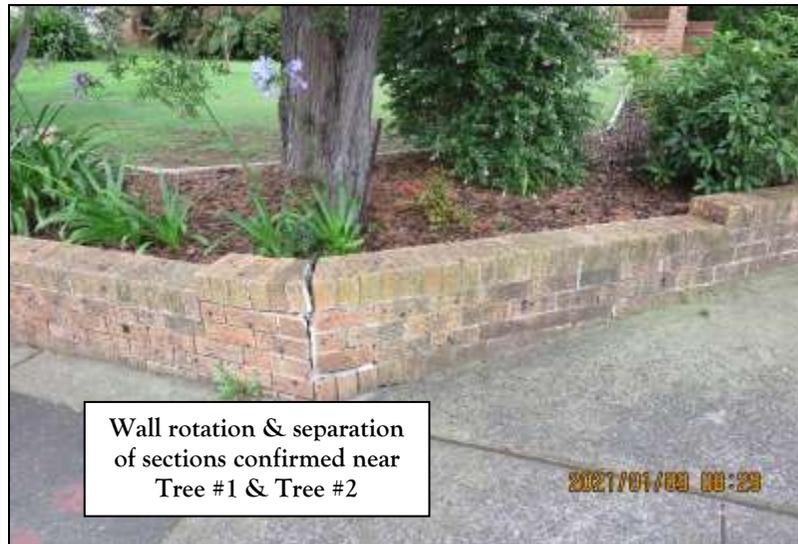
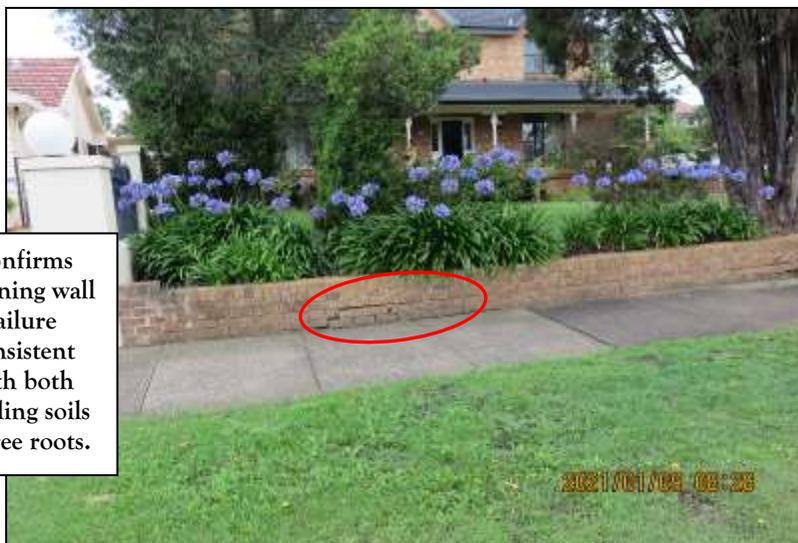
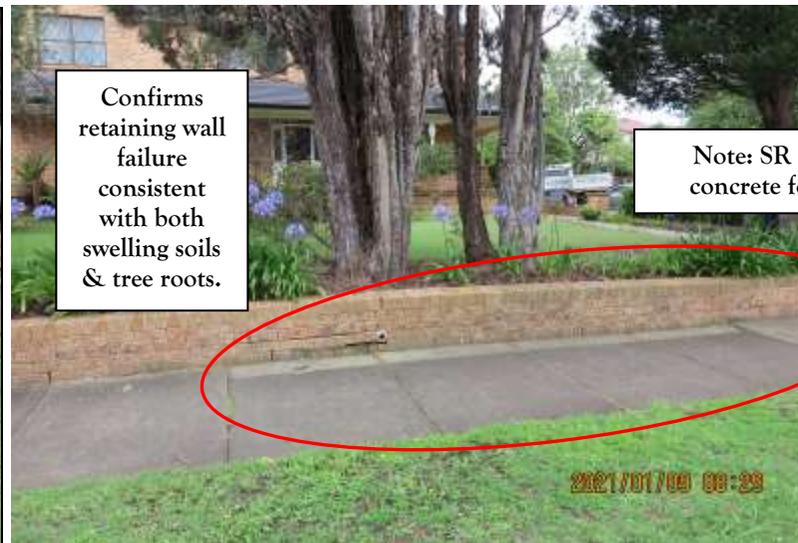
Figure 3: Above & previous page illustrates damage to the proposed to be replaced infrastructure relative to tree locations.

Damage to the existing & proposed to be replaced road reserve common boundaries masonry retaining walls is obvious. Whilst in almost all situations it is impossible to establish a 'primary cause' to damaged infrastructure it is obvious by damage locations the discussed trees are significant contributing factors. It is also likely the masonry retaining wall was built with insufficient drainage so as to relieve pressure to the structure from saturated soils (medium clay in the local area) swelling & pushing against the total structure. This is the most likely the most significant contributing factor relative to the rotation of the masonry retaining wall sections. Simply, the as can be seen from page 8 photographs confirming the presence of the PVC plastic pipes randomly inserted are not likely to be part of the original structure.

All four (4) discussed trees calculated 'Structural Root Zone' radial distances are breached by the existing masonry boundary/retaining wall. By best practice 'Arboriculture Management Principles' this is not considered to be a sustainable situation relative to mitigating 'risk to the public'.

- Demolish the existing infrastructure, i.e., common boundary with public roads low masonry boundary/retaining wall.
- Remove the discussed four (4) trees in compliance with the ‘Code of Practice: Amenity Tree Industry-SafeWork NSW’ document. Photographs are recommended to be taken whilst such works are being undertaken.

- Mechanically remove the four (4) tree stumps. Import suitable new soil/garden bed media. Stump grinding is an option, just not the ‘Arboriculture Best Practice’ preferred one. The reason being, when stumps are ground, they are mostly ‘out of sight as opposed to out of existence’. Secondly, any stump grinding woody tissue that mixes with surrounding soil is incompatible with any new tree roots until totally composted. (This takes at least a minimum of eighteen (18) months.) Lastly, if stump grinding does actually remove all major ‘root plate woody tissue’ it is likely to mix topsoil (A horizon) with subsoil (B horizon). This definitely not best practice to allow this to happen.
