2020 Scope of Work

Mascot pipeline verification dig

The Mascot pipeline is a 8" in pipeline that runs from the Clyde Terminal to JUHI (Mascot). The line carries aviation Jet-A-1(jet fuel). The line has a length of 23km, and a maximum allowable operating pressure, MAOP, of 90.5 bar.

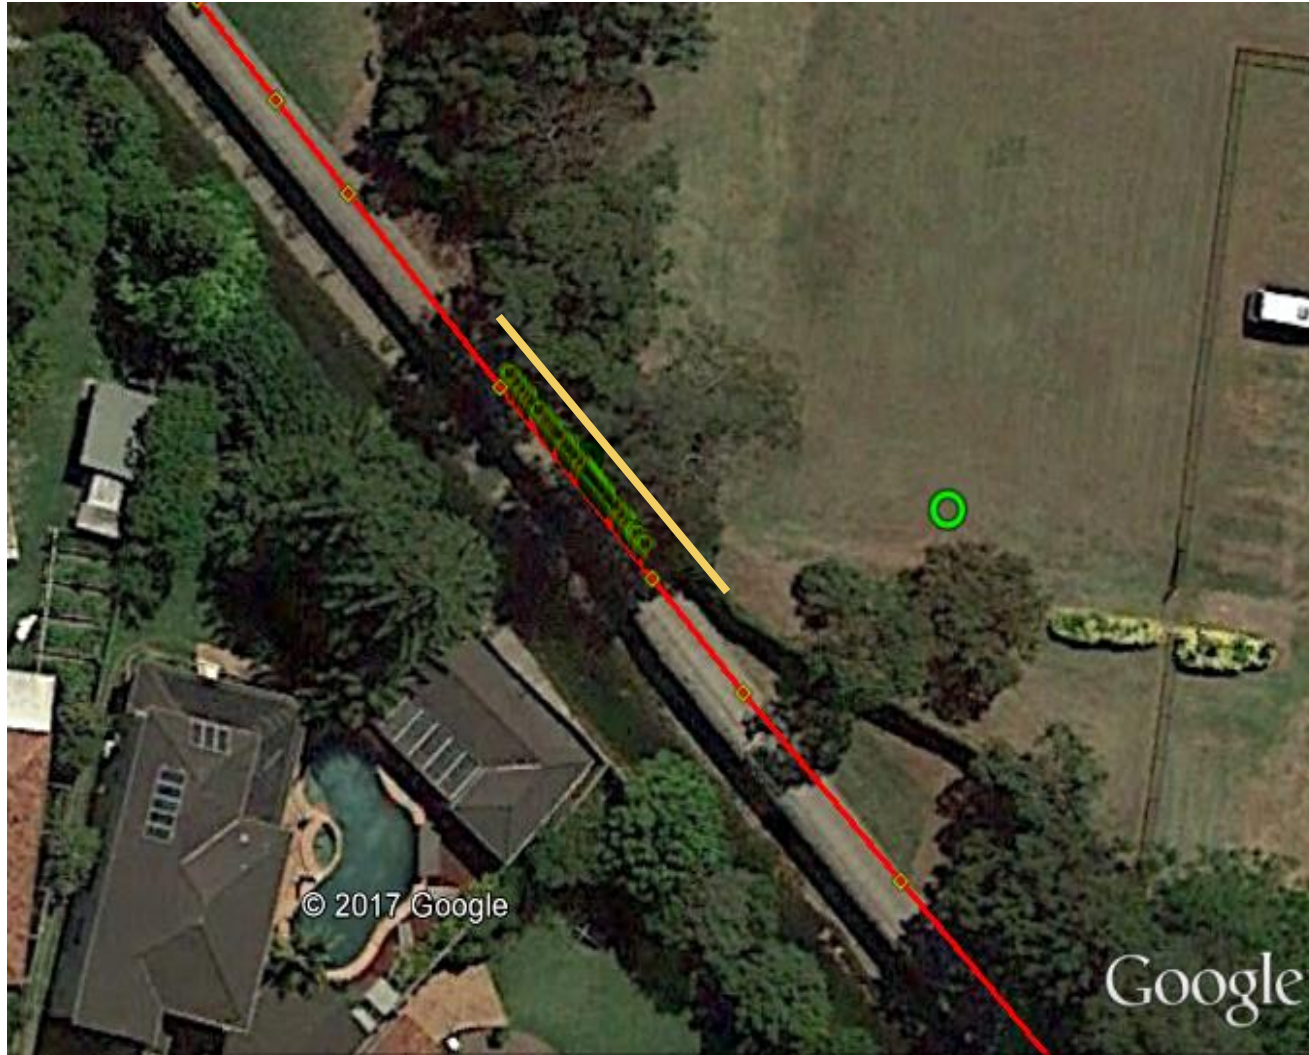
DEFECT REGION DETAILS

Overall Region	Log Distance (m)	Easting	Northing	Comments / Description
Start	11714.628	322136.7212	6248804.405	
End	11729.707	322146.7087	6248793.217

No.	Log Distance (m)		Start Co-ordinates		End Co-ordinates		Ref Attachment
		Start	End	Easting	Northing	Easting	Northing	
GW	2	11714.63	11729.71	322136.7212	6248804.405	322146.7087	6248793.217	
Corrosion	133	11715.55	11728.96					
Cracks	0							
Dents	0							
Douges	0

Figure 1: Detailed feature description for defect 1, LD 11714.628

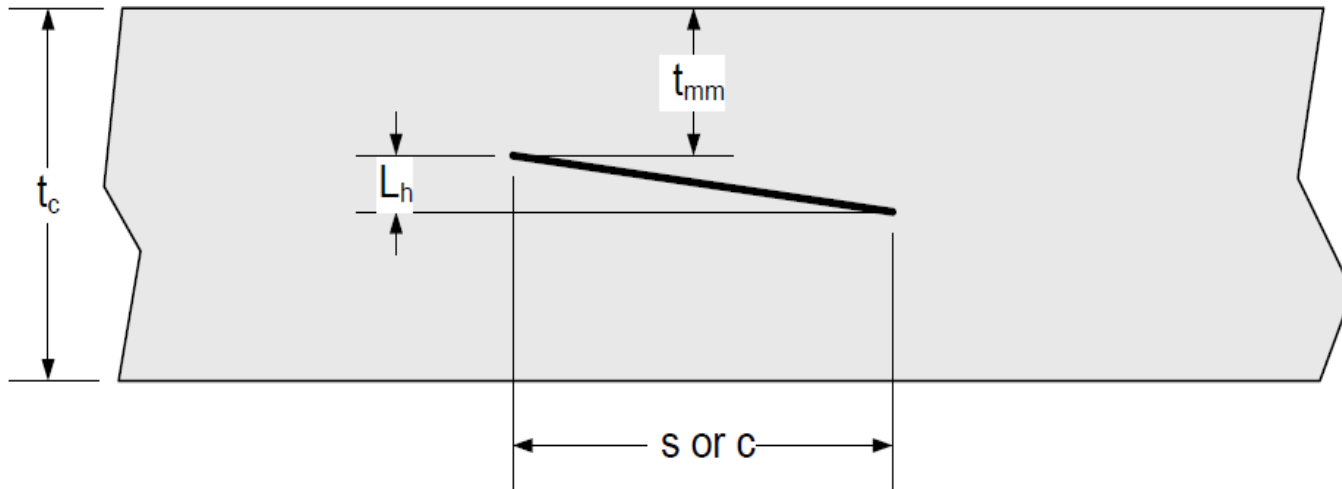
Section A-A
Cross Section Of Lamination
